**Water Quality Investigation  
of  
Three Embayments of Tellico Reservoir**

**ADDENDUM:  
FOLLOW UP SAMPLING IN 2017**

**Water Quality Improvement Committee  
Watershed Association of the Tellico Reservoir**

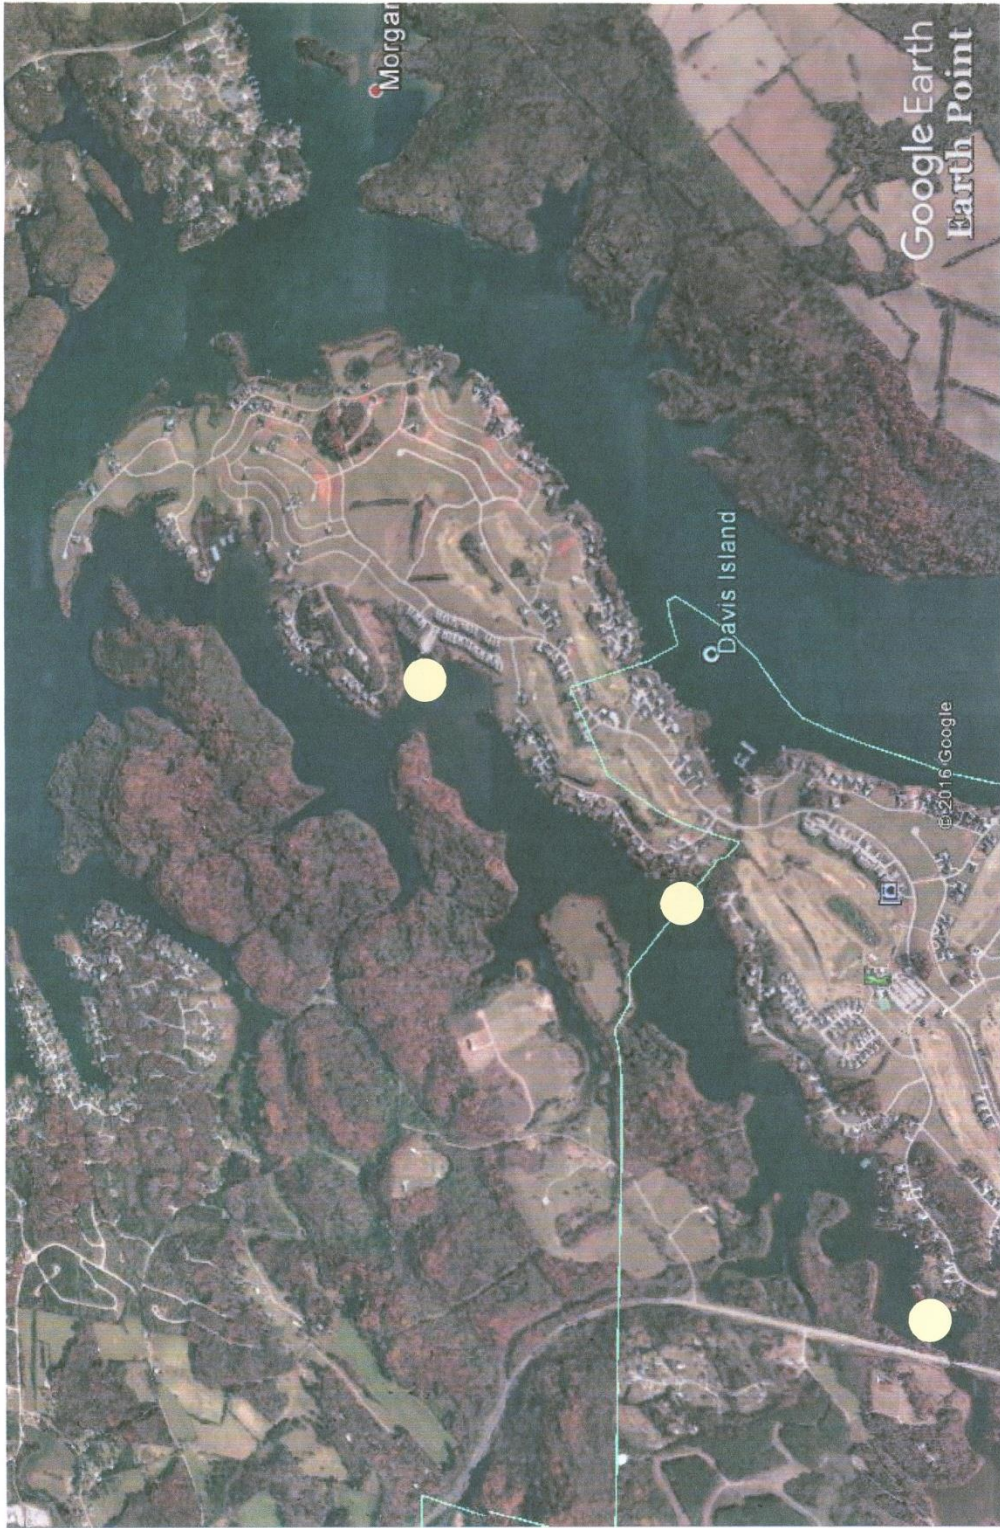
Figure 2: Aerial Photograph of Sample Sites in Bat Creek Embayment

The three sample sites for each embayment are denoted in aerial photographs presented in Figures 2, 3, and 4.

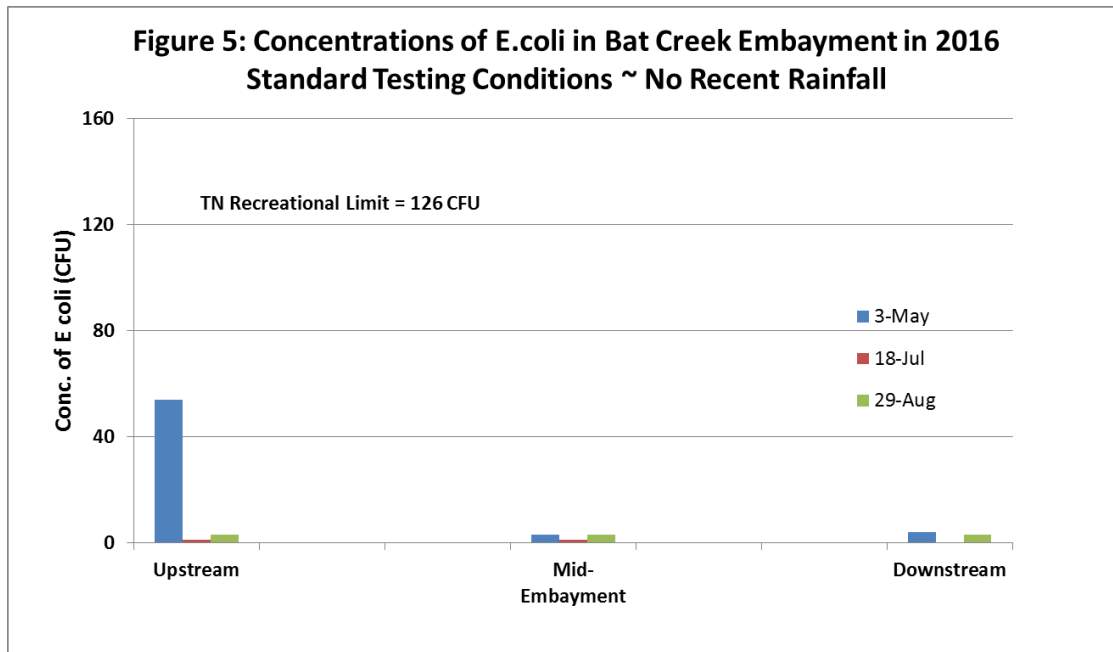
The E.coli concentrations at the three standard sampling sites, for all the sampled months, May to September, ranged from 0 to 120 colonies (per 100ml) with an overall geometric mean of 5.6 (N=12) (Figures 5 and 6). These values are well below the geometric mean criteria of 126 colonies and the absolute criteria of 487 colonies for lake waters to be classified suitable for recreational use (TN. State Statute Chapter 0400-40-03, April 2013).

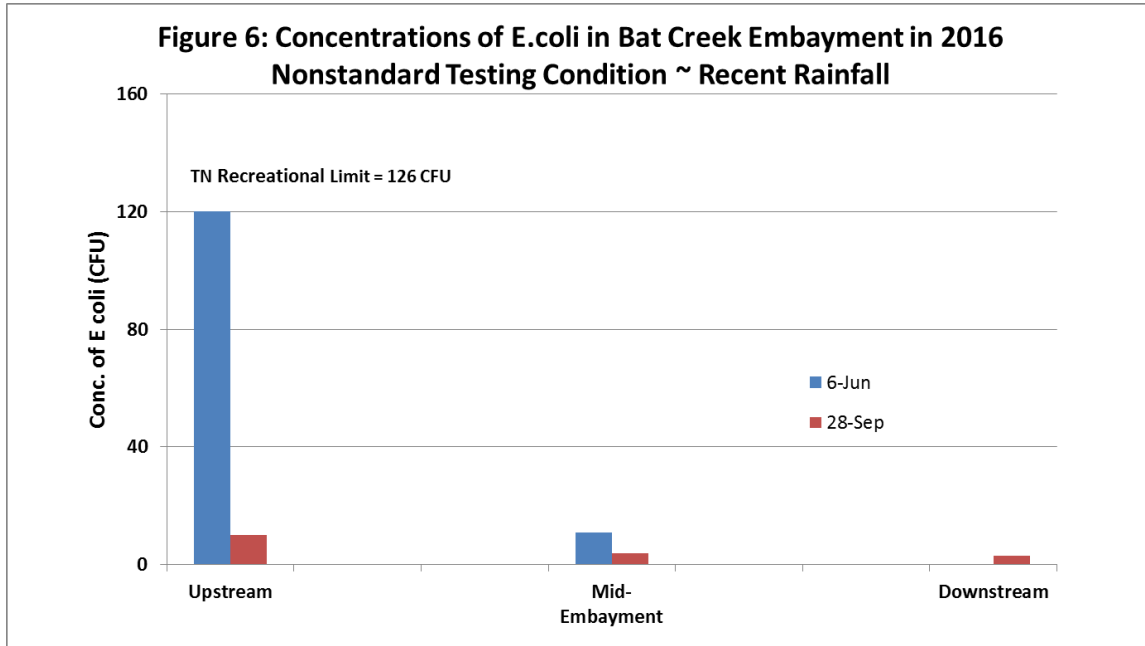
The maximum E.coli concentration found in the Bat Creek embayment was found in the June sampling that occurred after several heavy rain events (Figures 6 and 8). The June sampling event occurred about 24 hours after a two day rain event where 4.03 inch of rain fell. This rain event was preceded by a 1.49 inch rain, with only a 24 hour delay between the two events. The creek flowing into the embayment after this rain event was anticipated to have a very high E.coli count. Sampling by WQIC the previous month (May) as part of the Bat Creek Supplemental Environmental Project (SEP) found the E.coli levels where the creek entered the embayment to be high at 870 colonies (per 100ml). There had only been a trace amount of rain preceding that sampling. So, with this heavier rain event, instead of collecting a downstream embayment sample, a sample was collected in the pool above Route 72 to get better insight into what influence the creek was having on the E.coli concentration of the embayment. The E.coli concentration at the original upstream site located at the Highway 72 bridge, was 120 colonies. (This site was the farthest a boat would normally travel in May when the lake was filling from the lowered winter pool level). An alternate sample was collected from the pool upstream of Route 72 (Refer to figure 8 for illustration of the upper embayment sample sites). Although the sample from the pool above Route 72 was collected only about 1,500 feet from the Route 72 bridge site, the E.coli concentration in that

pool was high at 1,700 colonies. Moving downstream from the 72 bridge the E.coli concentration at the mid-embayment sample site was only 11 colonies. It is not known if or how far that slug of high E.coli water extended downstream into the Bat Creek embayment of Tellico Reservoir in the days after the sampling.

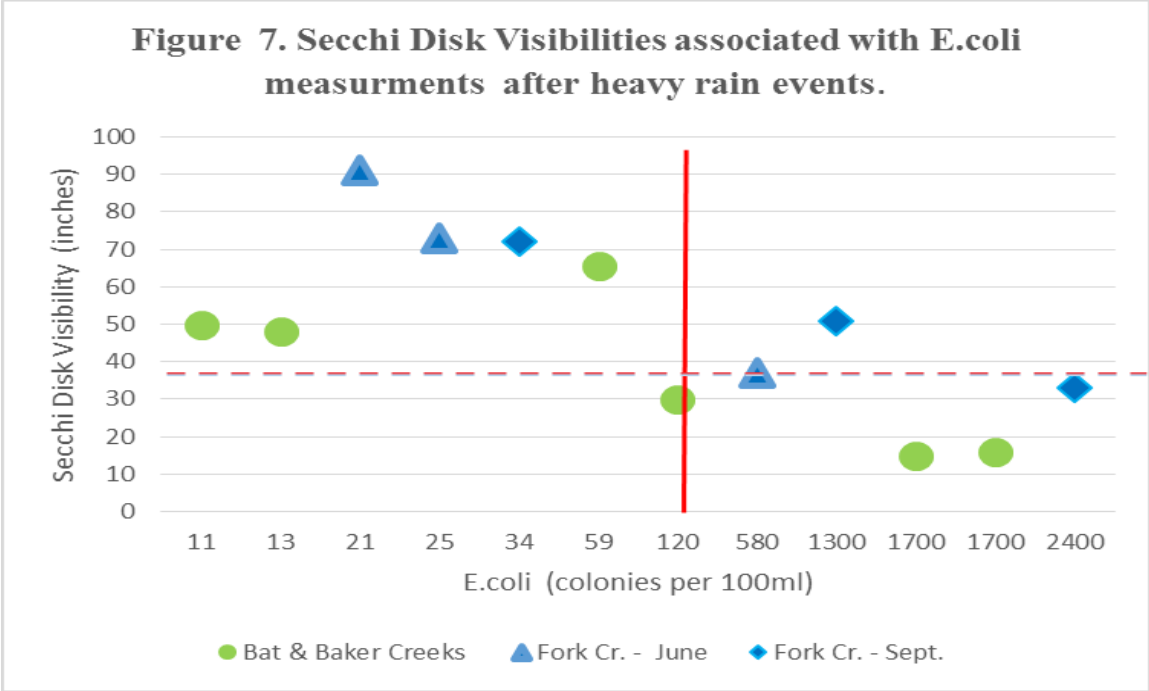
The high E.coli concentrations found after the heavy rain event in June were associated with muddy or murky water where secchi disk visibilities were 30 inches or less for Bat Creek and Baker Creek and less than 40 inches for Fork Creek. (Figure 7). For the September rain event high E.coli were found in Fork Creek with clearer water. A heavy rain in early fall can wash in lots of organic matter from harvested fields. This organic matter seems to neutralize the colloquial properties of mud (personal observation of the co-author).

It is suggested that after a heavy rain event the public should exhibit caution in waters of the upper part of the embayment, and any waters that appear muddy or murky with mud. The high E.coli concentrations were associated with muddy or murky water where secchi disk visibilities were 30 inches or less (Figure 7).

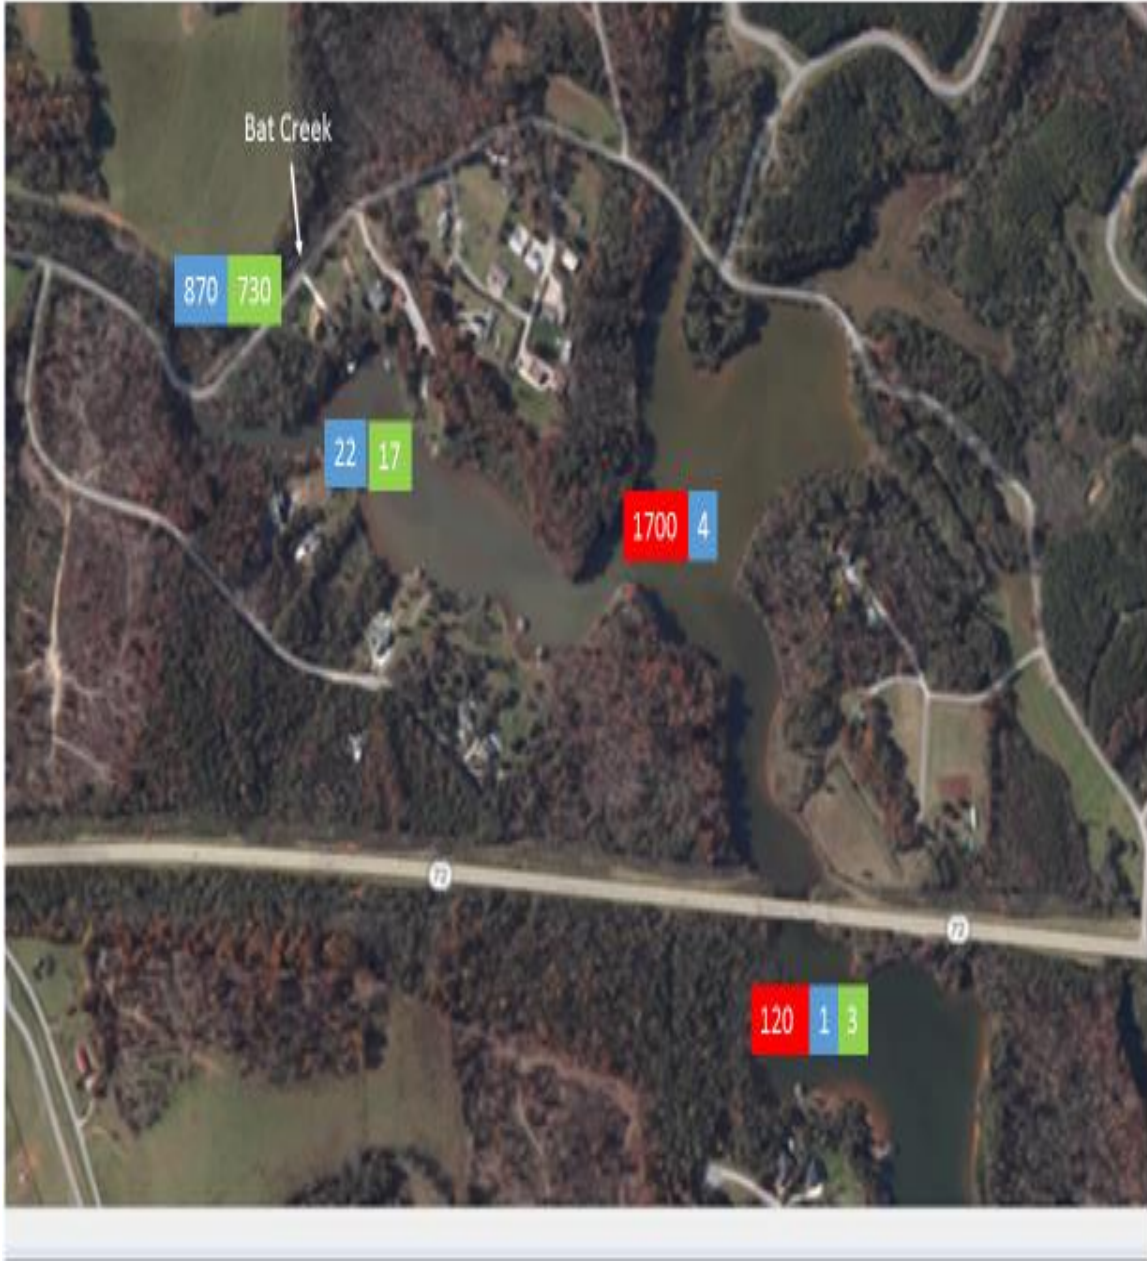
Additional sampling was undertaken in July and August to further evaluate what influence the creek was having on E.coli in the embayment. Sampling by WQIC in 2016 for the Bat Creek Supplemental Environmental Project (SEP) found the E.coli levels where the creek entered the embayment to be high: In the uppermost pool where the creek entered the embayment, the E.coli ranged from 250 to 870 colonies (per 100ml) with a geometric mean of 604 (n=5). During July and August an additional sample for this embayment study was collected in the pool immediately downstream of the Lakeside Drive crossing of Bat Creek, a mere 1200 feet downstream from where samples were collected for the Bat Creek SEP project. Although E.coli levels in the creek were 870 and 730 colonies, 5 and 7 days, respectfully, prior to sampling in the downstream pool, E.coli in the pool was only 22 and 17 colonies, respectfully. In the next pool downstream, the pool above the 72 bridge, where the E.coli concentration was 1700 colonies in June, it had fallen to a mere 4 colonies in the July sample.

Figure 8. E.coli colonies (MPN/100ml) measured in the upper pools of the Bat Creek embayment. The values in red are those for June, after a heavy rain event. Those values in blue are for the month of July, and green for the month of August.

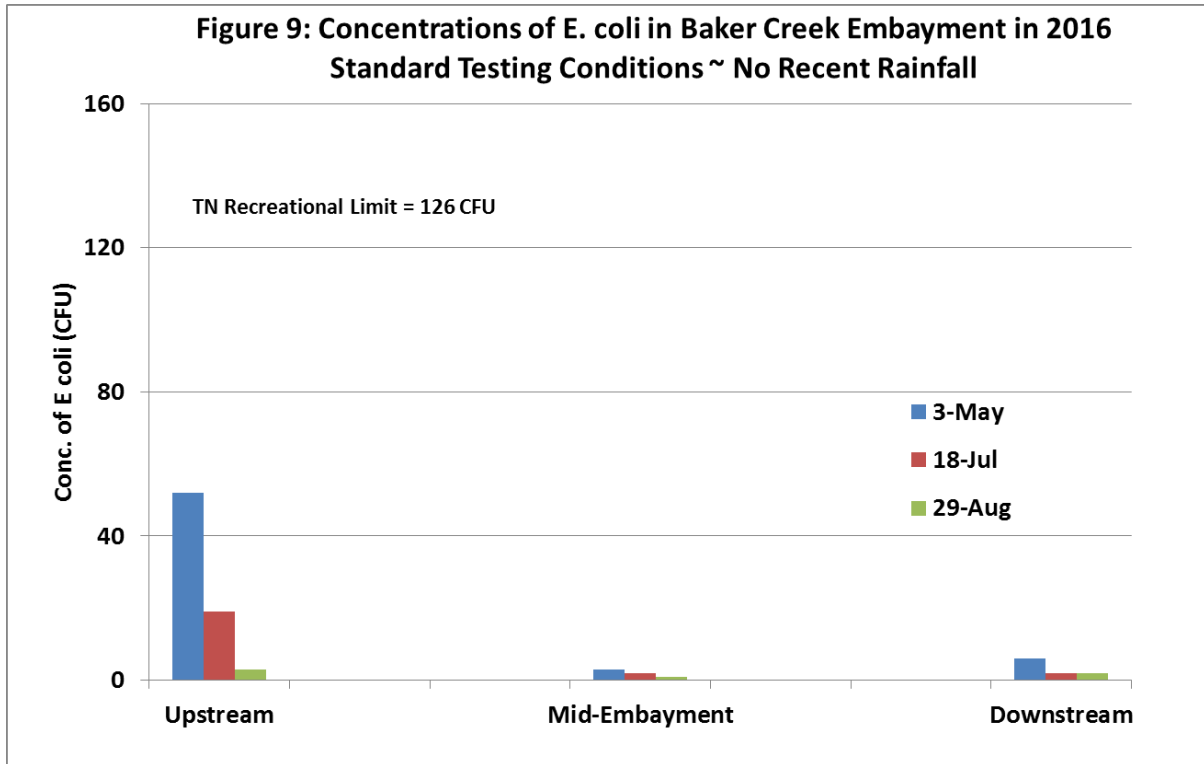
The E.coli concentrations during May, July, and August (Figure 9) ranged from 1 to 52 colonies (per 100ml) with an overall geometric mean of 4.2 (N=9). These values are well below the geometric mean criteria of 126 colonies per 100ml and the absolute criteria of 487 per 100ml for lake waters to be classified suitable for recreational use (TN. State Statute Chapter 0400-40-03, April 2013).

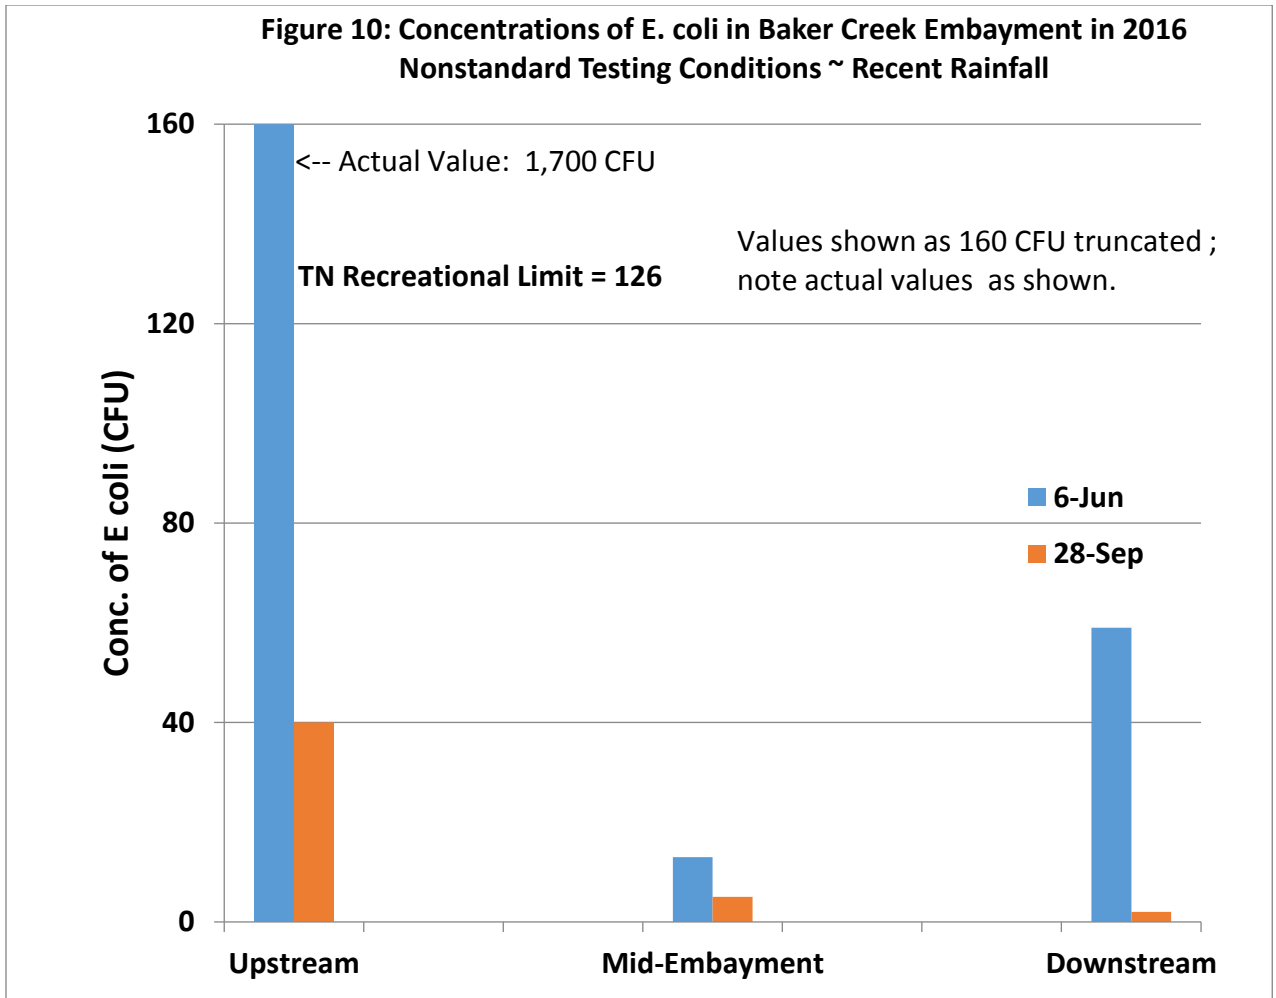
During the months of June and September, when sampling occurred after heavy rains (Figure 10), most of the E.coli concentrations remained low, 2 to 59 colonies, except the uppermost sample site in June the concentration was 1700 colonies. The high E.coli, like that at Bat Creek, was associated with turbid muddy water.

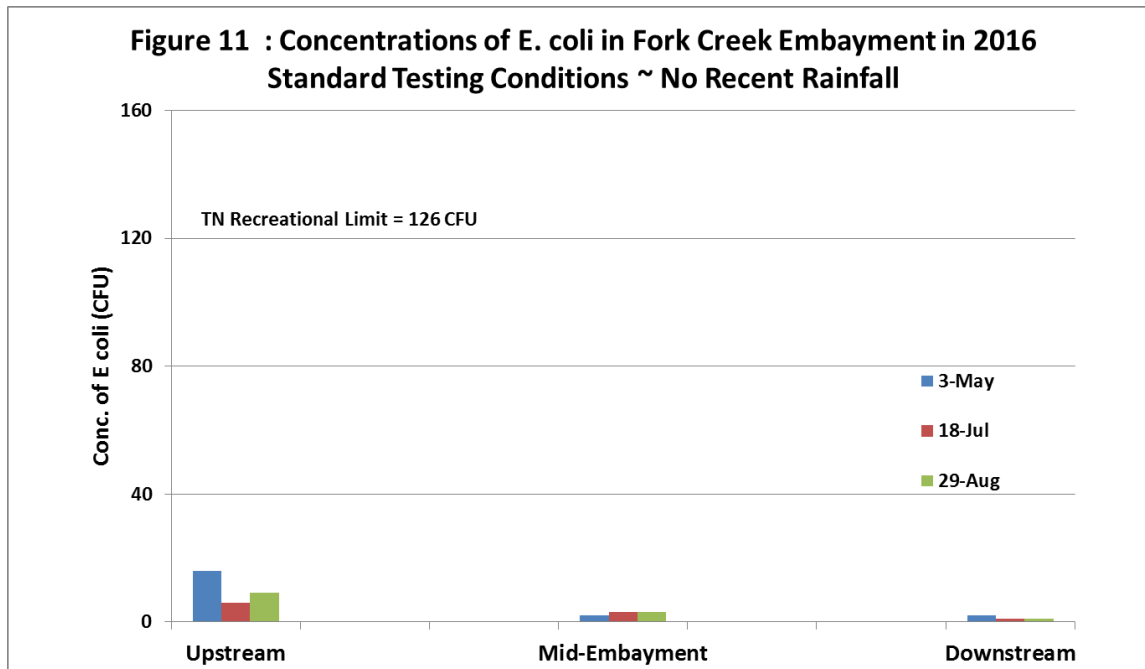
The E.coli concentrations during May, July, and August (Figure 11) ranged from 1 to 16 colonies (per 100ml) with an overall geometric mean of 3.2 (N=9). These values are well below the geometric mean criteria of 126 colonies per 100ml and the absolute criteria of 487 colonies per 100ml for lake waters to be classified suitable for recreational use (TN. State Statute Chapter 0400-40-03, April 2013).

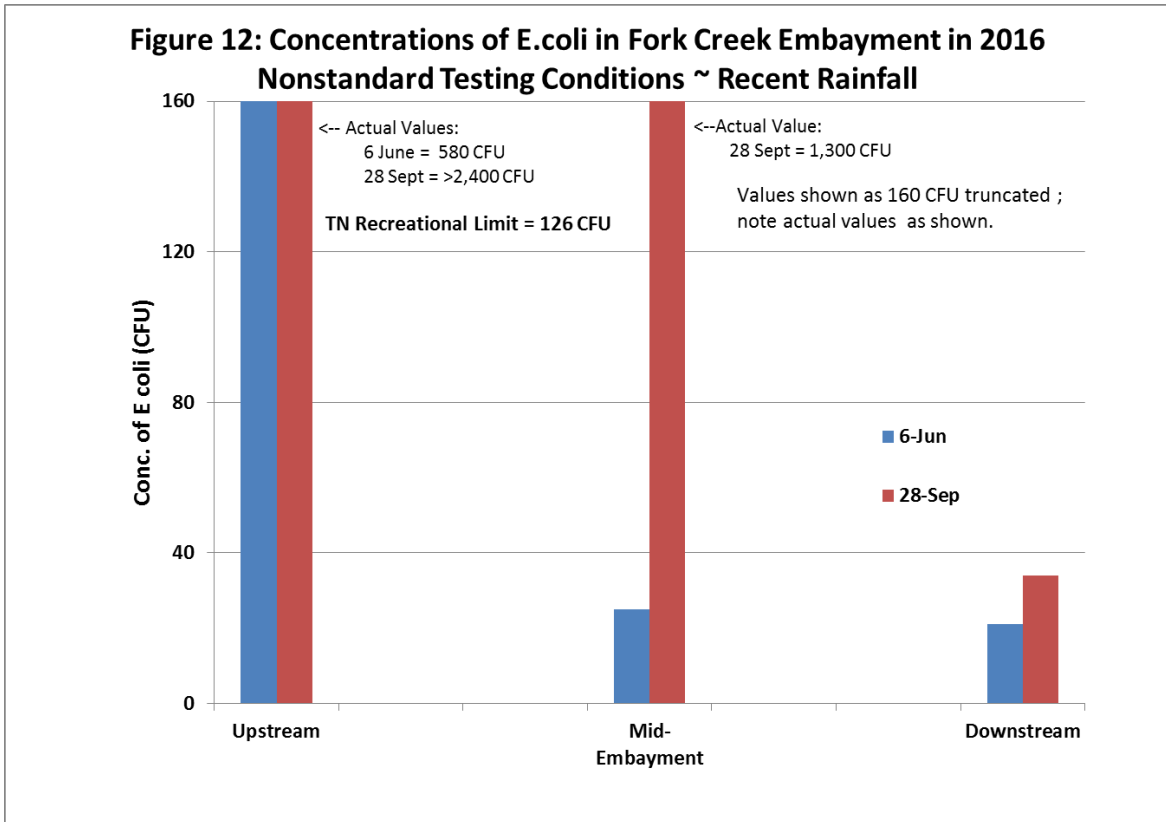
During the months of June and September, when sampling occurred after heavy rains, several samples had E.coli concentrations in excess of 500 colonies (Figure 12).

The elevated concentrations of E.coli at the upstream sample site following periods of heavy rainfall were as expected and consistent with results from the other two embayments. However, the high concentration of E.coli recorded at the mid-embayment site was not only inconsistent with data at this location following the June rainfall, but also the trend from the other two embayments following heavy rainfall. Additional sampling of this embayment after a major rainfall event is planned for the summer of 2017 to define the trend of E.coli concentrations over several days.

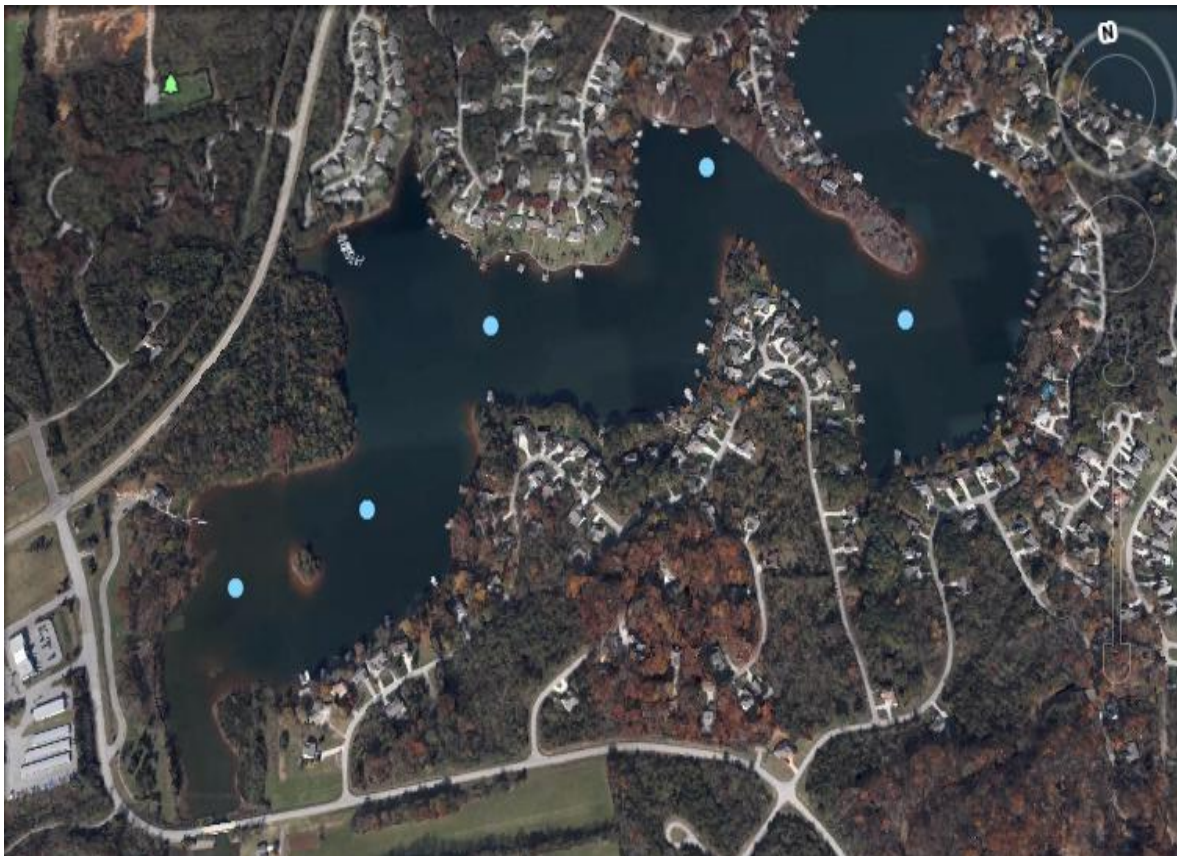
Sites sampled in Fork Creek embayment in 2017.

Site	Site Name	Location
Fork 1	Mialaqua Bridge	Downstream of Mialaqua Bridge at point in lake about midway along a line between first pier on North shore and first pier on South shore
Fork 2	Inagehi Way Island	1 <sup>st</sup> buoy past island (second buoy)
Fork 3	Chatuga Way shore	past 2nd buoy after island (3rd buoy; green buoy across from Marina) and collect sample in middle of channel out from red pier
Fork 4	Inagehi Circle Point	Upstream buoy of the group of 3 buoys off of the point on Inagehi Circle
Fork 5	Kiyuga Lane Point	Next buoy downstream of the group of buoys; off of point on Kiyuga Lane

Fork 1      Fork 2      Fork 3      Fork 4      Fork 5

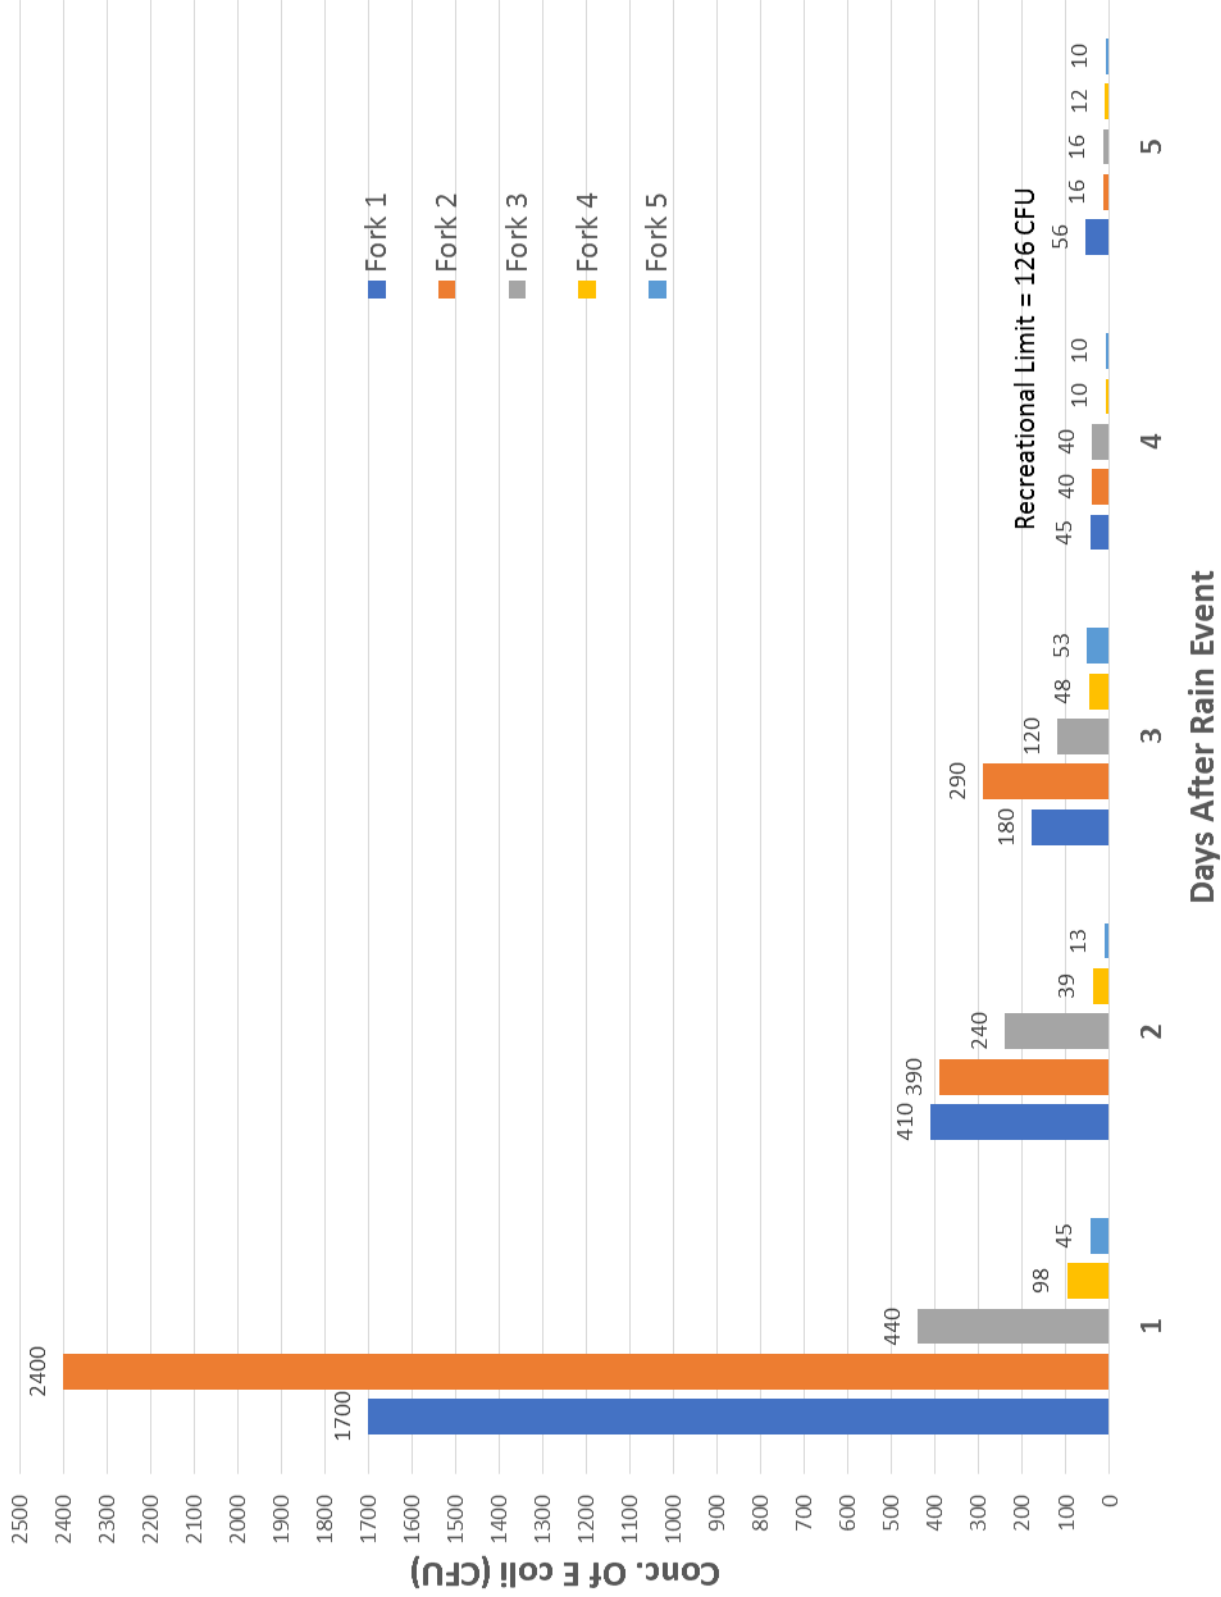
# Concentration of E coli in Fork Creek Embayment for Days After Heavy Rain Event in 2017

Sample site Fork 4 was sampled both in 2016 and 2017. During 2017 the maximum E.coli concentration found was 98 MPN. The E.coli concentration at this site in September 2016 was 1,300 MPN.

During 2017, WQIC volunteers sampled the Fork Creek embayment for five consecutive days after a heavy rain event to determine the penetration of E. coli into the embayment and to measure how long it took for the bacteria to decompose. The results confirmed the WQIC recommendation in 2016 regarding water contact following a heavy rain event. Based on an analysis of the data, **the WQIC advises that people should avoid contact with water in the shallow end of the embayment, where polluted creeks enter the reservoir, for three days following a heavy rain event.** Swallowing or swimming in water contaminated with pathogenic strains of E. coli can lead to an infection, with symptoms of abdominal pain, diarrhea, and fever. E.coli bacteria is an indicator of recent fecal contamination. As such, other more serious pathogens may be present at high concentrations of E.coli.
